REPORT BMS18

Structural Properties of  
"Pre-Fab" Constructions for  
Walls, Partitions, and Floors  
Sponsored by the  
Harnischfeger Corporation

NATIONAL  
BUREAU OF STANDARDS

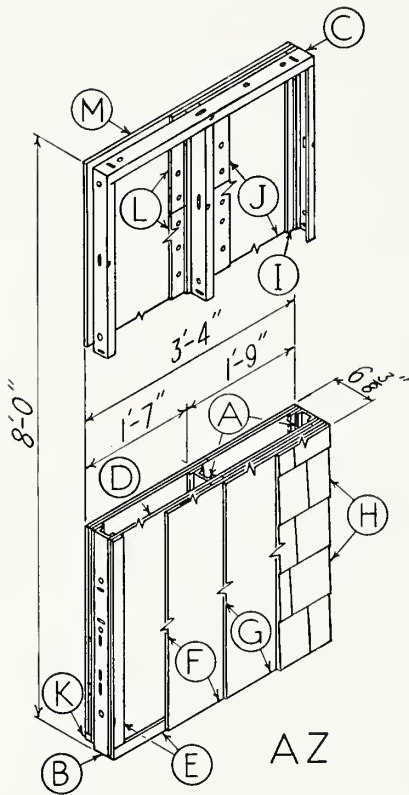
FIGURE 1.—Three-foot four-inch wall specimen AZ.

A, stud; B, sill; C, wall plate; D, insulation; E, furring strip; F, sheathing; G, sheathing paper; H, shingle siding; I, furring strip; J, moisture barrier; K, ground; L, lath; M, plaster.

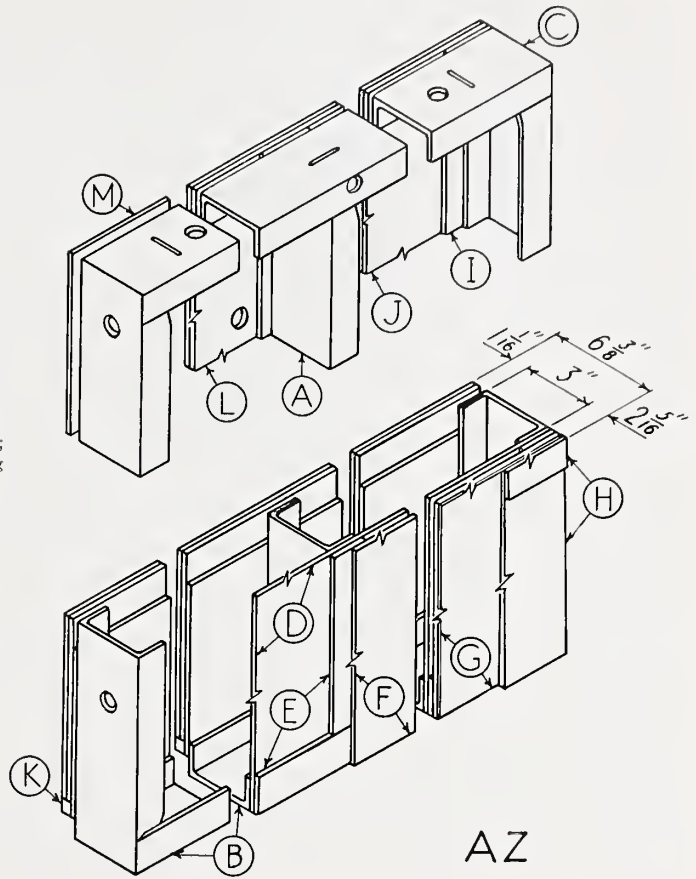
FIGURE 2.—Details of wall specimen AZ.

A, stud; B, sill; C, wall plate; D, insulation; E, furring strip; F, sheathing; G, sheathing paper; H, shingle siding; I, furring strip; J, moisture barrier; K, ground; L, lath; M, plaster.

fastened to the inside of the flange near the lower end by welds. There was one  $\frac{3}{8}$ -in. tapped hole through each plate and flange for bolt connections to a floor panel.

*Sill.*—The sill, B, was 3 ft  $3\frac{3}{8}$  in. long and identical in section with the studs, A. The web had two transverse and one longitudinal slot,  $1\frac{1}{16}$  by  $\frac{3}{16}$  in., and three  $\frac{3}{8}$ -in. holes. Each flange had a  $\frac{1}{2}$ -in. hole opposite the longitudinal slot.

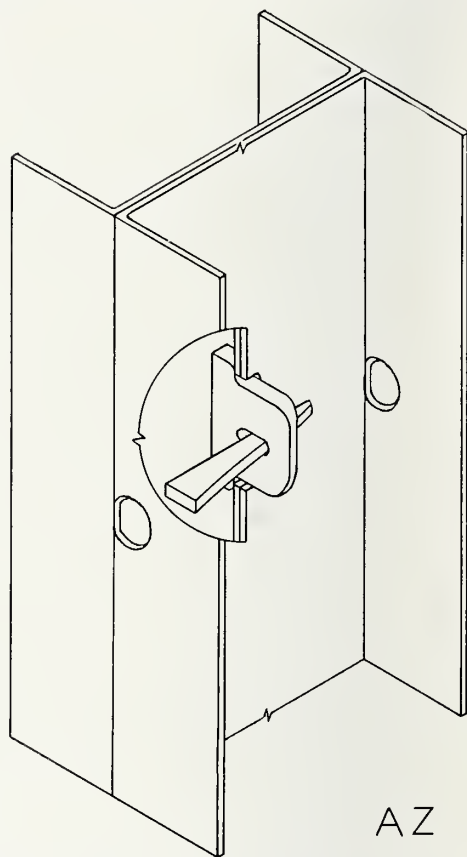
FIGURE 3.—Method of interlocking wall panels with key-and-pin fastenings

are laid on top of the foundation walls to form a bearing for the floor and wall panels. The wall panels are fastened to the floor panels by bolts and to adjacent wall panels by the key-and-pin fastenings shown in figure 3. Corners are made with a corner panel fastened by key-and-pin fastenings to the wall panels. Panels

for second-story walls rest on sheet-steel brackets, which support the second floor, and are fastened to the first-story panels by key-and-pin fastenings. Doors and windows are installed in panels at the factory.

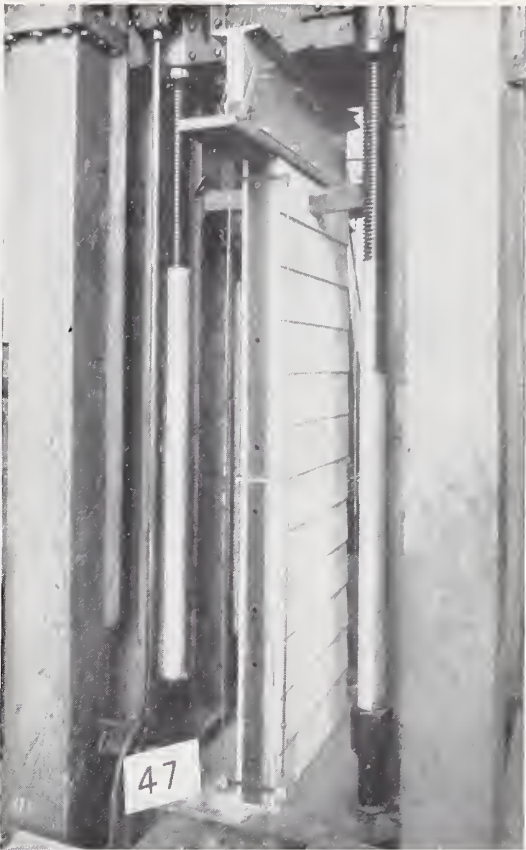
FIGURE 4.—Wall specimen *AZ-C2* under compressive load

Each of the specimens failed by buckling of one or more studs near midheight. In each case the buckling occurred at holes in the flanges of the studs. For specimen *C1* the plaster and lath separated from the lower end of the specimen.

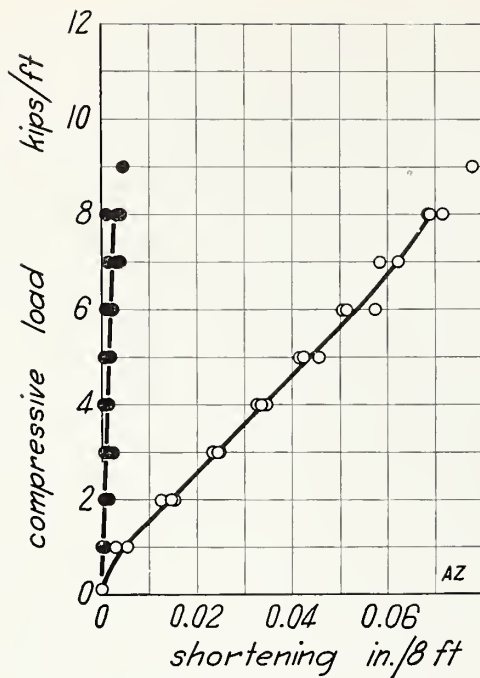
FIGURE 5.—Compressive load on wall AZ.

Load-shortening (open circles) and load-set (solid circles) results for specimens AZ-C1, C2, and C3. The load was applied 2.06 inches from the inside face. The loads are in kips per foot of actual width of specimen.

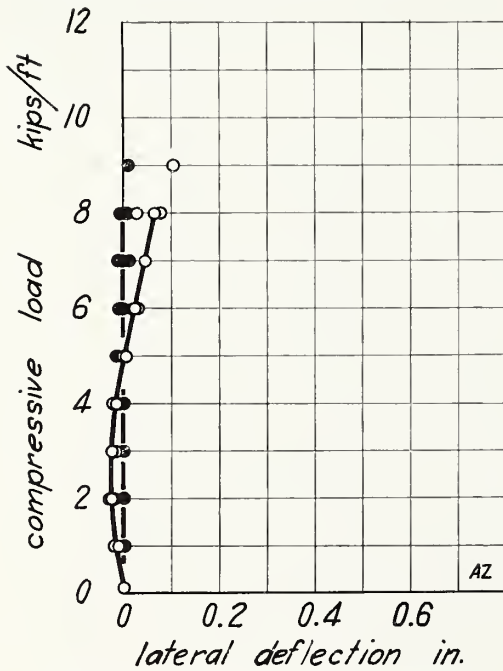
FIGURE 6.—Compressive load on wall AZ.

Load-lateral deflection (open circles) and load-lateral set (solid circles) results for specimens AZ-C1, C2, and C3. The load was applied 2.06 inches from the inside face. The loads are in kips per foot of actual width of specimen. The deflections and sets are for a gage length of 7 ft 4 in., the gage length of the deflectometers.

For determining the eccentricity of loading in the compressive test, the thickness of the specimens was taken as the thickness of the studs, and the compressive loads were applied one-third the thickness of the studs from the inside edge of the studs. The shortenings and sets shown in figure 5 for a height of 8 ft were computed from the values obtained from the compressometer readings. The gage length of the compressometers was 7 ft 6 in. The lateral deflections shown in figure 6 are plotted to the

right of the vertical axis for deflections of the specimens toward the outside face, and to the left for deflections toward the inside face. For compressive loads up to about 5 kips/ft the specimens deflected toward the inside face, because the stiffness of the inside face more than offset the effect of the eccentric loading. For loads greater than 5 kips/ft the specimens deflected in the opposite direction, that is, toward the outside face, possibly because of progressive local failure of the inside face.

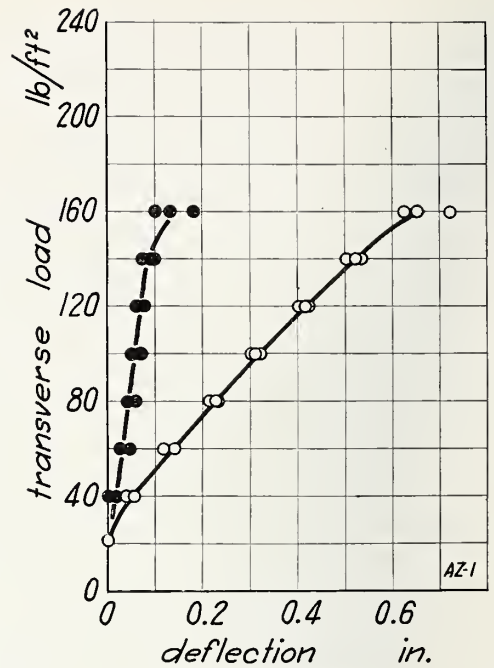
FIGURE 7.—Transverse load on wall AZ, load applied to inside face.

Load-deflection (open circles) and load-set (solid circles) results for specimens AZ-T1, T2, and T3 on the span 7 ft 6 in.

The results are shown in table 8 and in figure 7 for wall specimens *AZ-T1*, *T2*, and *T3*, loaded

Each of the specimens *T1*, *T2*, and *T3* failed by buckling of the studs near midspan at holes in the flanges of the studs.

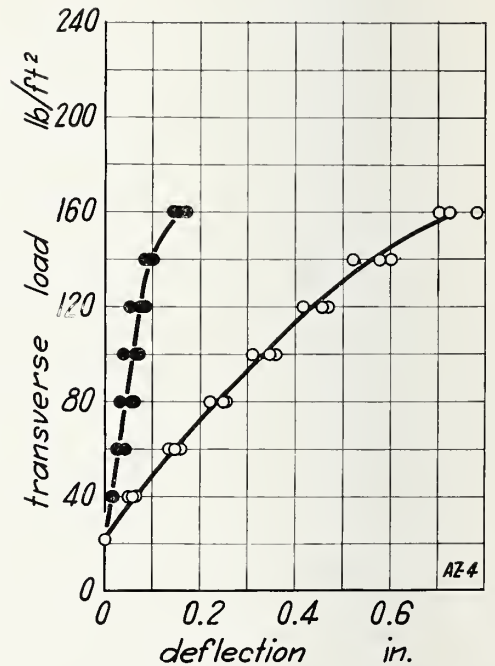
FIGURE 8.—Transverse load on wall AZ, load applied to outside face.

Load-deflection (open circles) and load-set (solid circles) results for specimens AZ-T4, T5, and T6 on the span 7 ft 6 in.

For each of the specimens *T4*, *T5*, and *T6* the plaster cracked transversely across the speci-

men in two or more places between the loading rollers. The first cracks occurred at loads of 110, 160, and 160 lb/ft<sup>2</sup> and deflections of 0.41, 0.72, and 0.70 in. for specimens *T4*, *T5*, and *T6*, respectively. Each of the specimens failed by buckling of the studs near midspan at holes in the flanges of the studs.

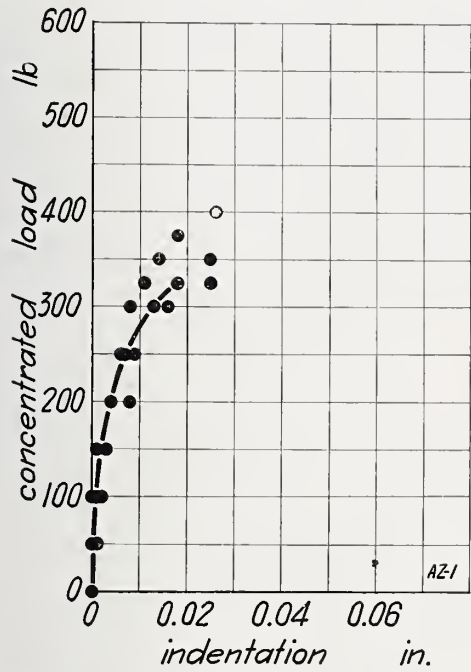
FIGURE 9.—Concentrated load on wall *AZ*, load applied to inside face.

Load-indentation results for specimens *AZ-P1*, *P2*, and *P3*.

The results are shown in table 8 and in figure 9 for wall specimens *AZ-P1*, *P2*, and *P3*, loaded on the inside face, and in figure 10 for wall specimens *AZ-P4*, *P5*, and *P6*, loaded on the outside face.

The concentrated loads were applied to the inside face of specimens *P1*, *P2*, and *P3* on the plaster midway between two studs. Each of

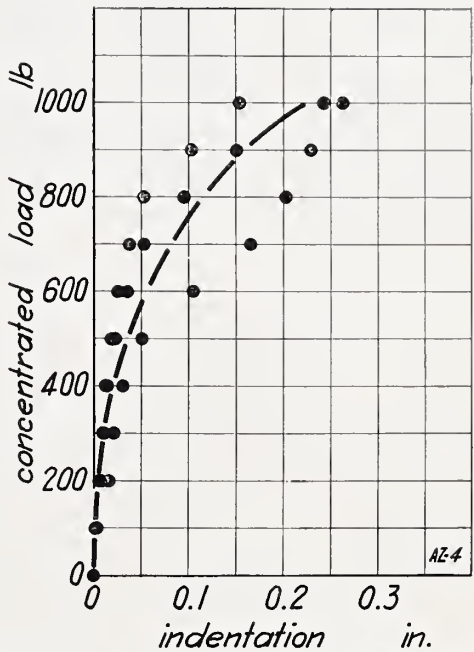
FIGURE 10.—Concentrated load on wall *AZ*, load applied to outside face.

Load-indentation results for specimens *AZ-P4*, *P5*, and *P6*.

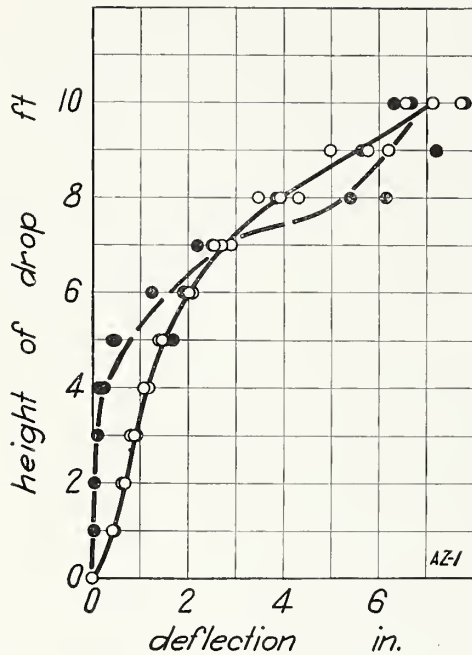
FIGURE 11.—Impact load on wall AZ, load applied to inside face.

Height of drop-deflection (open circles) and height of drop-set (solid circles) results for specimens AZ-*I1*, *I2*, and *I3* on the span 7 ft 6 in.

The deflections shown in figure 11 were obtained from measurements to the outside face, whereas the sets were measured to the inside face. For drops greater than 7 ft, some of the sets exceeded the deflections because the inside face failed and the center stud deformed to

The impact loads were applied to the center of the inside face of specimens *I1*, *I2*, and *I3*, the sandbag striking the plaster approximately over the center stud. At drops of 2.5, 2, and 3 ft for specimens *I1*, *I2*, and *I3*, respectively, the plaster inside face of each specimen cracked

transversely across the specimen at a lath joint. The deflections at these drops were 0.80, 0.69, and 0.80 in. for specimens *I1*, *I2*, and *I3*, respectively. At drops of 3.5, 3.5, and 4 ft for specimens *I1*, *I2*, and *I3*, respectively, the inside face of each specimen failed by rupture of the lath and plaster under the sandbag. For specimens *I1* and *I3* after a drop of 10 ft the sheathing was separated from the furring strips and all the studs buckled. For specimen *I2* after a drop of 10 ft the sheathing was separated from the furring strips and the center stud buckled.

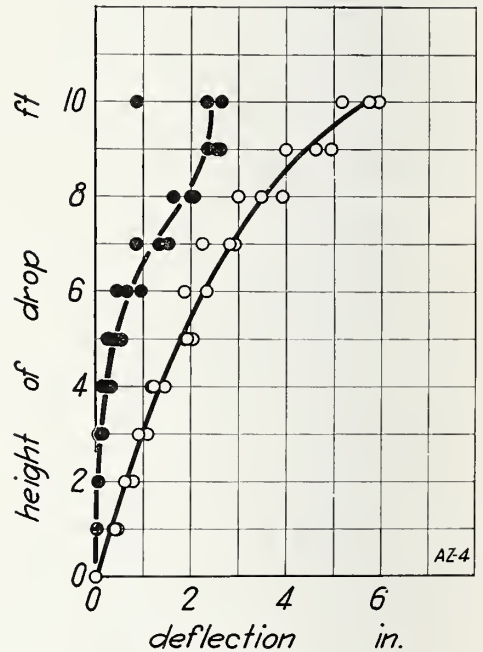
FIGURE 12.—Impact load on wall AZ, load applied to outside face.

Height of drop-deflection (open circles) and height of drop-set (solid circles) results for specimens AZ-*I4*, *I5*, and *I6* on the span 7 ft 6 in.

The results are shown in table 8 and in figure 11 for wall specimens *AZ-I1*, *I2*, and *I3*, loaded on the inside face, and in figure 12 for wall

3.5, and 3 ft for specimens *I4*, *I5*, and *I6*, respectively, the plaster inside face of each specimen cracked transversely across the specimen at a lath joint. The deflections at these drops were 0.80, 1.08, and 1.10 in. for specimens *I4*, *I5*, and *I6*, respectively. At drops of 3, 5.5 and 3.5 ft for specimens *I4*, *I5*, and *I6*, respectively, the inside face of each specimen failed by one or more pieces of lath with plaster (40 by 16 in.) falling down. For each specimen after a drop of 10 ft most of the inside face had fallen down in pieces, the sheathing separated from the furring strips, and the studs buckled.

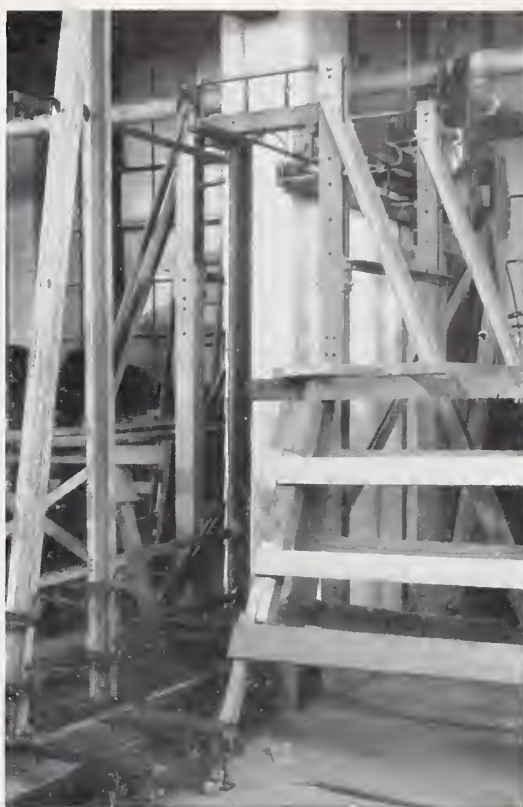
FIGURE 13.—Wall specimen *AZ-R3* under racking load.

Wall specimen AZ-*R3* under racking load is shown in figure 13. The results for wall speci-

Each of the specimens failed by the insulation and sheathing separating from one or more studs in the panel to which the load was applied. The screws fastening the double wall to the studs and wall plate deformed under the shearing load and the heads of some of the screws finally pulled through the flanges of the studs and wall plate. In addition, the heads of some of the nails fastening the lath to the furring strips pulled through the lath. For specimen *R1* there was a slight crack in the plaster at the middle of the specimen and for specimen *R3* a crack near the upper end.

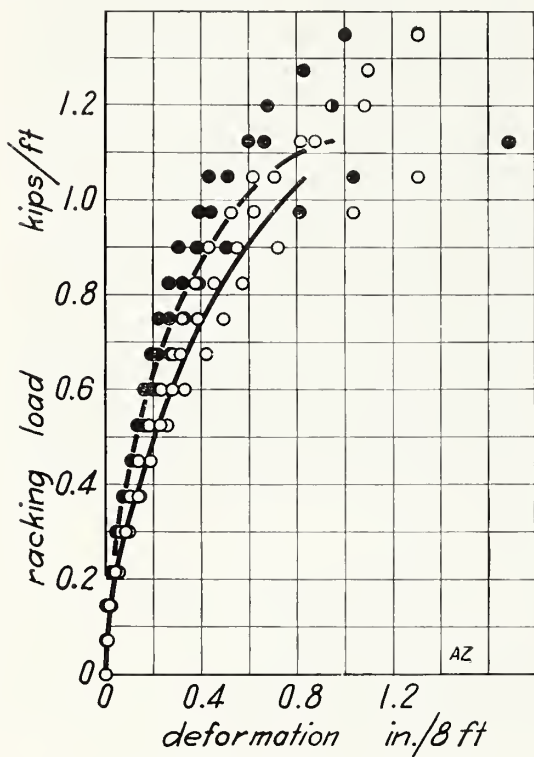
FIGURE 14.—Racking load on wall AZ.

Load-deformation (open circles) and load-set (solid circles) results for specimens AZ-R1, R2, and R3. The loads are in kips per foot of actual width of specimen.

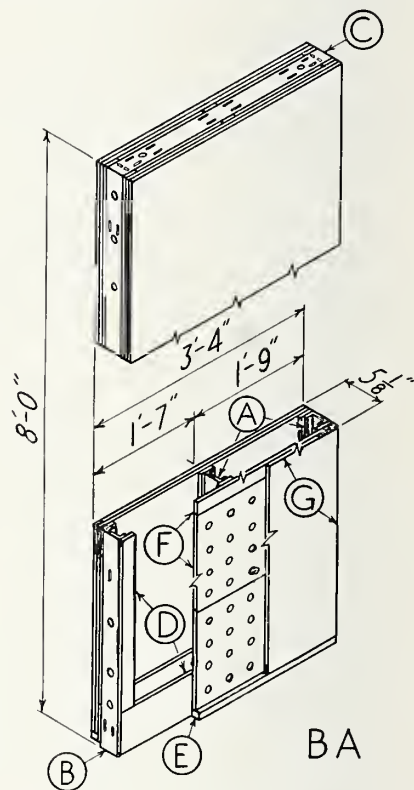
FIGURE 15.—Partition specimen BA.

*A*, stud; *B*, soleplate; *C*, top plate; *D*, furring strips; *E*, ground; *F*, lath; *G*, plaster.

*Soleplate.*—The soleplate, *B*, was a channel, 3 by ¾ in., 3 ft 3⅝ in. long, formed from sheet steel, No. 15 U. S. Std. Gage (0.0689 in. thick). The web had four slots, 1½ by ⅜ in., and four slots, 2⅝ by ¼ in., for fastenings, and four ⅝-in. holes for conduits. Each flange had four slots, ⅝ by ½ in., and two ½-in. holes.

*Top plate.*—The top plate, *C*, was 3 ft 3⅝ in. long and identical in section with the soleplate, *B*. The web had 16 slots, 1½ by ⅜ in.,

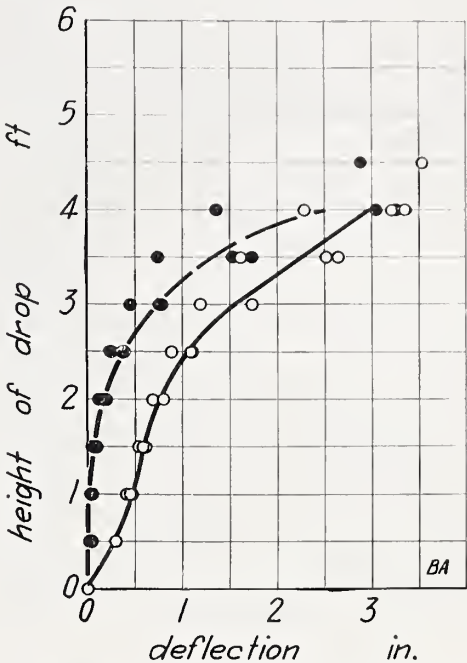
FIGURE 16.—Impact load on partition BA.

Height of drop-deflection (open circles) and height of drop-set (solid circles) results for specimens *BA-I1*, *I2*, and *I3* on the span 7 ft 6 in.

The impact loads were applied to the center of one face of each specimen, the sandbag striking the plaster approximately over the center stud. At drops of 2, 1.5, and 1 ft for

specimens *I1*, *I2*, and *I3*, respectively, the plaster face, opposite the face to which the load was applied, cracked transversely across the speci-

men at a lath joint. The deflections at these drops were 0.69, 0.58, and 0.47 in., respectively. At drops of 2.5, 1.5, and 2 ft for specimens *I1*, *I2*, and *I3*, respectively, the plaster face to which the load was applied cracked transversely across the specimen. Each of the specimens failed by rupture of the loaded face, falling down of the opposite face in pieces, buckling of the center stud at midspan, and bending of the soleplate and top plate.

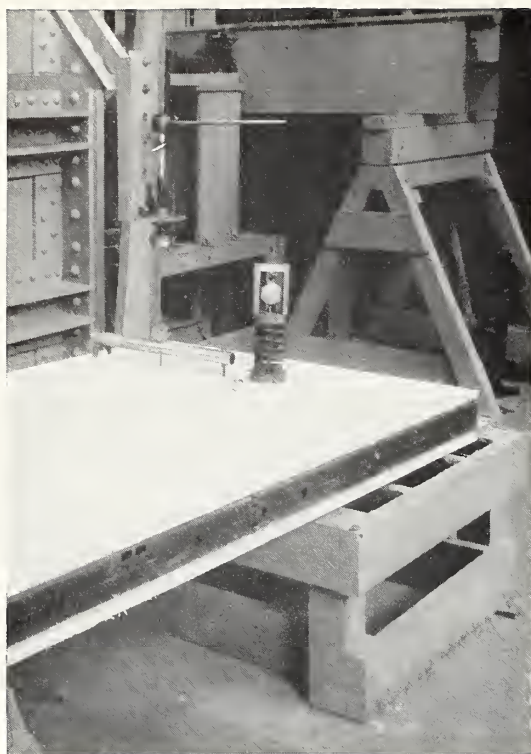
FIGURE 17.—Partition specimen BA-P2 under concentrated load.

Partition specimen *BA-P2* under concentrated load is shown in figure 17. The results for partition specimens *BA-P1*, *P2*, and *P3*, are shown in table 9 and in figure 18.

The concentrated loads were applied to one face of each specimen on the plaster midway between two studs. Each of the specimens failed by punching of the disk through the loaded face.

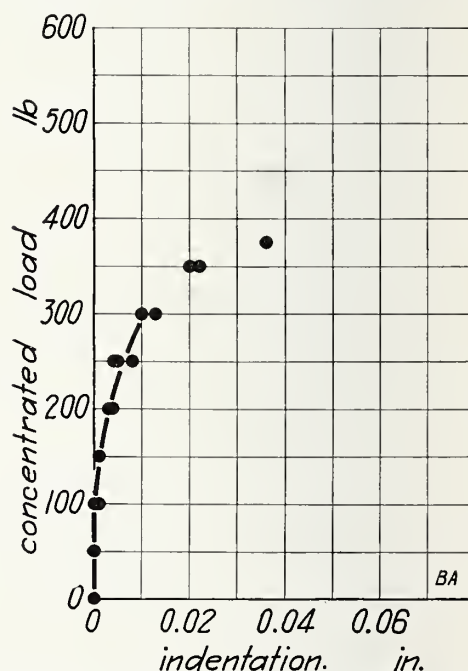
FIGURE 18.—Concentrated load on partition BA.

Load-indentation results for specimens BA-P1, P2, and P3.

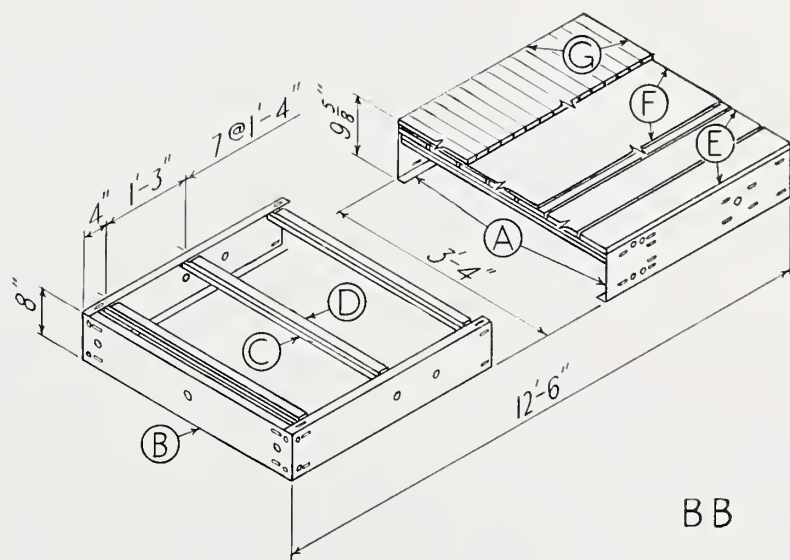
FIGURE 19.—Floor specimen BB.

*A*, joist; *B*, end member; *C*, cross strut; *D*, nailing strip; *E*, subfloor; *F*, sheathing paper; *G*, finish floor.

The floor specimens were 12 ft 6 in. long, 3 ft 4 in. wide, and  $9\frac{5}{8}$  in. thick. Each specimen consisted of a welded sheet-steel frame to which the subfloor and finish floor were fastened. The frame consisted of two sheet-steel joists, *A*, shown in figure 19, spaced 3 ft 4 in. from web to web and fastened to sheet-steel end members,

ing strips were the same as *C* and *D* (fig. 19), but inverted and fastened so that the nailing strips were flush with the bottom of the joists. The lower struts were directly below the upper struts.

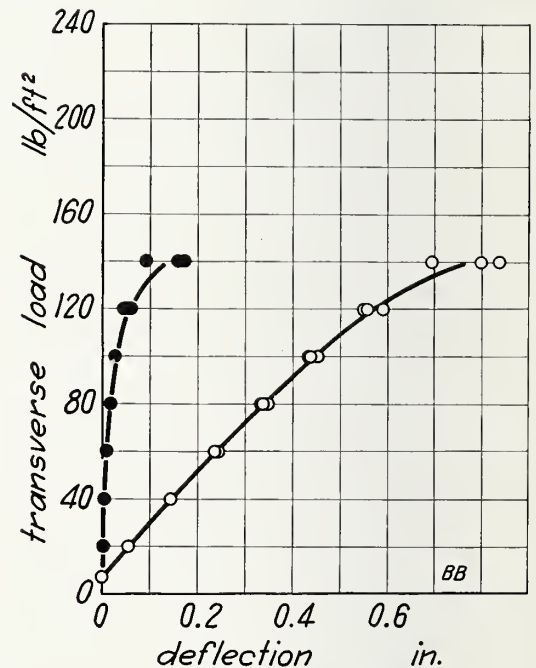
FIGURE 21.—Transverse load on floor *BB*.

Load-deflection (open circles) and load-set (solid circles) results for specimens *BB-T1*, *T2*, and *T3* on the span 12 ft 0 in.

Each of the specimens failed by buckling of both joists at or between the loading rollers. No failure of the wood finish floor was observed.

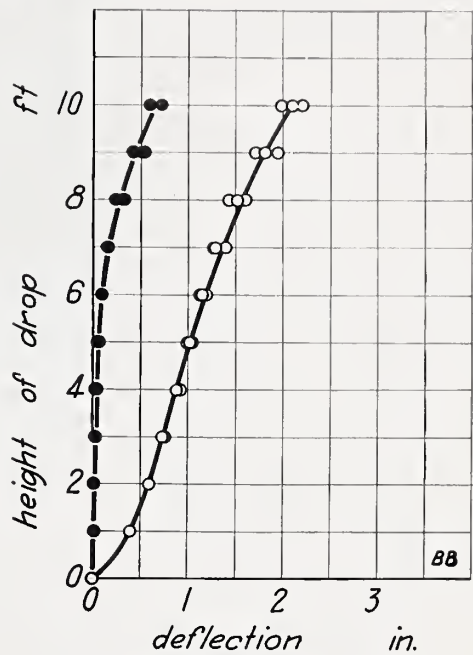
FIGURE 23.—Impact load on floor *BB*.  
Height of drop-deflection (open circles) and height of drop-set (solid circles) results for specimens *BB-I1*, *I2*, and *I3* on the span 12 ft 0 in.

The impact loads were applied to the center of the upper face of each specimen, the sandbag striking the finish floor midway between the joists and midway between two cross struts. The sets after a drop of 10 ft were 0.72, 0.73, and 0.60 in. for specimens *I1*, *I2*, and *I3*, respectively. For specimen *I1*, one joist buckled, and for specimens *I2* and *I3* both joists buckled at midspan. No failure of the wood finish floor was observed.

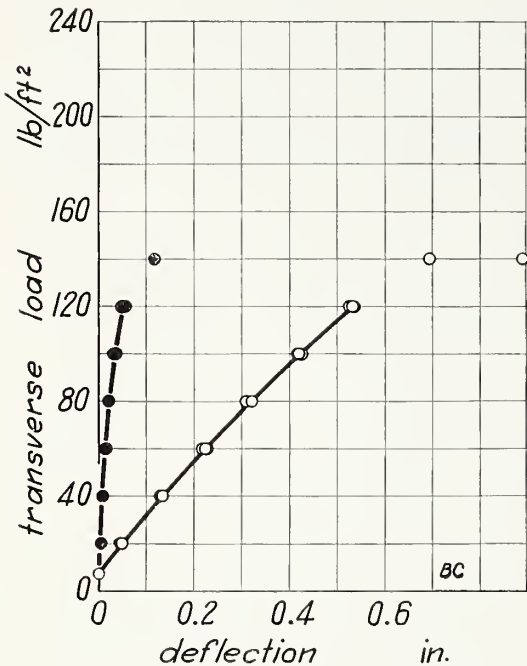
FIGURE 24.—Transverse load on floor BC.

Load-deflection (open circles) and load-set (solid circles) results for specimens BC-*T1*, *T2*, and *T3* on the span 12 ft 0 in.

At loads of 80, 100, and 80 lb/ft<sup>2</sup> for specimens *T1*, *T2*, and *T3*, respectively, the plaster

ceiling of each specimen cracked transversely across the specimen at a lath joint. The deflections at these loads were 0.32, 0.42, and 0.32 in. for specimens *T1*, *T2*, and *T3*, respectively. The ceiling of specimen *T2* cracked at another lath joint at the maximum load. Each of the specimens failed by buckling of both joists at or between the loading rollers. The buckling occurred at holes in the upper flanges of the joists.

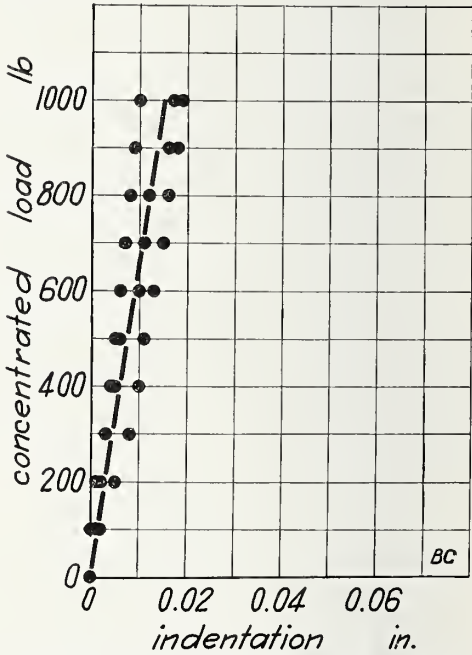
FIGURE 25.—Concentrated load on floor BC.

Load-indentation results for specimens BC-*P1*, *P2*, and *P3*.

The concentrated loads were applied to the finish floor of each specimen on a strip of the flooring near an end-matched joint which was not directly over a cross strut. The indentations after a load of 1,000 lb had been applied were 0.017, 0.010, and 0.019 in. for specimens *P1*, *P2*, and *P3*, respectively, and no other effect was observed.

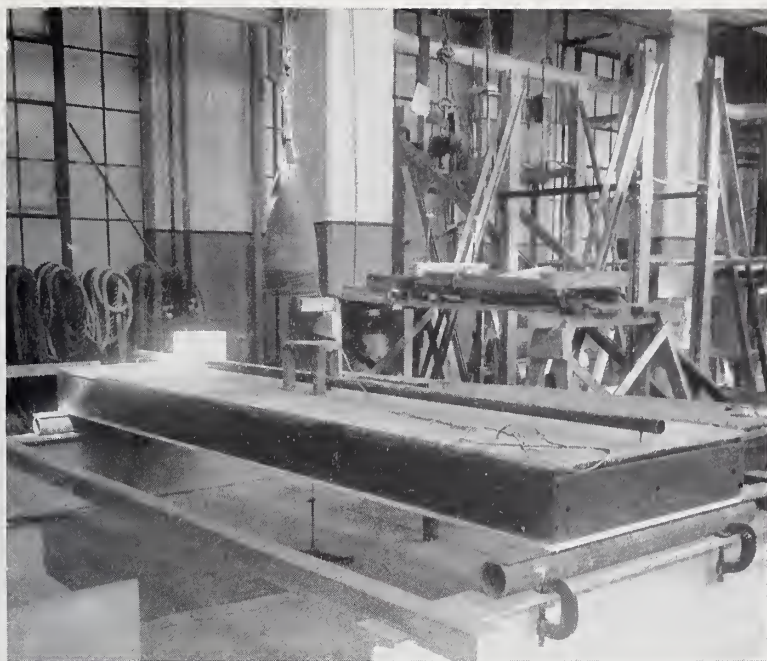
FIGURE 26.—Floor specimen *BC-11* during impact test.

Floor specimen *BC-11* under impact load is shown in figure 26. The results for floor specimens *BC-11*, *12*, and *13* are shown in table 11 and in figure 27.

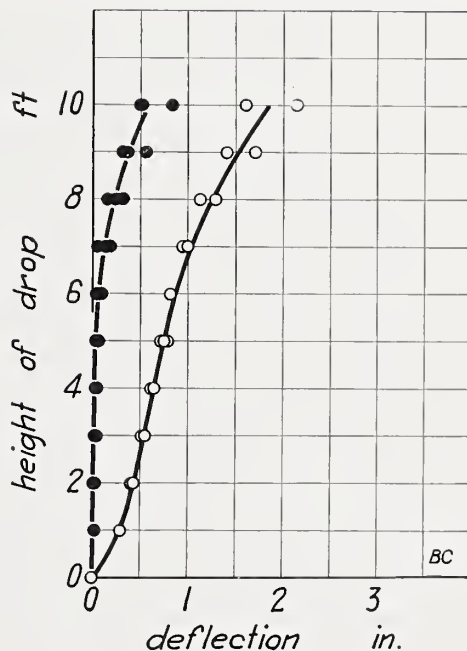
FIGURE 27.—Impact load on floor *BC*.

Height of drop-deflection (open circles) and height of drop-set (solid circles) results for specimens *BC-11*, *12*, and *13* on the span 12 ft 0 in.

The impact loads were applied to the center of the upper face of each specimen, the sandbag

Specimen *I1* had an initial transverse crack across the plaster ceiling. The ceiling of specimens *I2* and *I3* cracked transversely across each specimen at a drop of 1 ft. For each of the specimens *I1*, *I2*, and *I3* at drops of 3.5, 9.0, and 4.5 ft, respectively, one piece of lath with plaster (40 by 16 in.) fell down. The sets after a drop of 10 ft were 0.83, 0.50, and 0.52 in. for specimens *I1*, *I2*, and *I3*, respectively. For specimen *I1* most of the plaster ceiling had fallen down in pieces, and both joists buckled at midspan. For specimen *I2* about one-half and for *I3* most of the plaster ceiling had fallen down in pieces, and one joist in each specimen buckled at midspan. No failure of the wood finish floor was observed.
